R&R the Running Boards

Bill Lee
30 May 2014

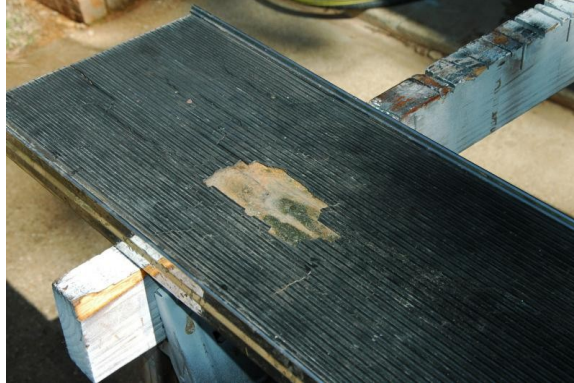
The car was parked facing west, the sun was always on the driver's side of the car. When I got the car, shortly I found that the tires on that side of the car had deteriorated badly as had the rubber on the running board. I surmise it was because those parts of the car were not covered and exposed to the sun for 20+/- years. A couple of years ago, I replaced all four tires. And last year I decided to also replace the rubber on the running boards.

Thinking this would be a simple fix, I ordered replacement rubber mats from Snyders. This past month, as I was preparing for the mini-tech session we had, I decided to do it.

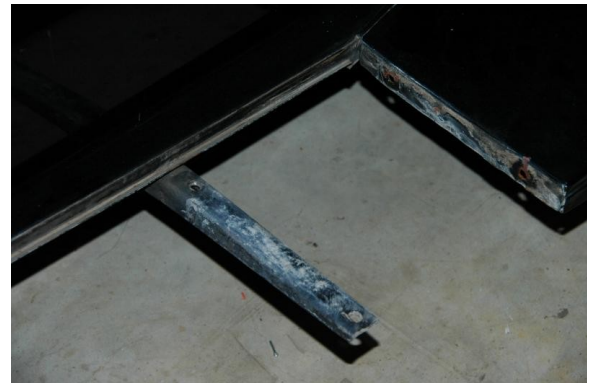
First item: take them off the car. On my '29 Tudor, that means unbolting them from the fenders and the running board braces. No big deal. But getting them out from between the fenders without scratching up the paint was a bit of a hassle. A little care and it was done.

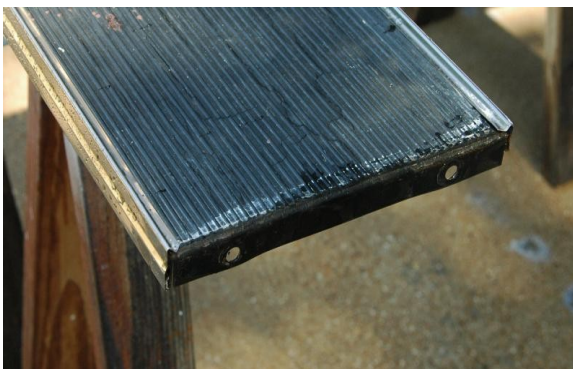
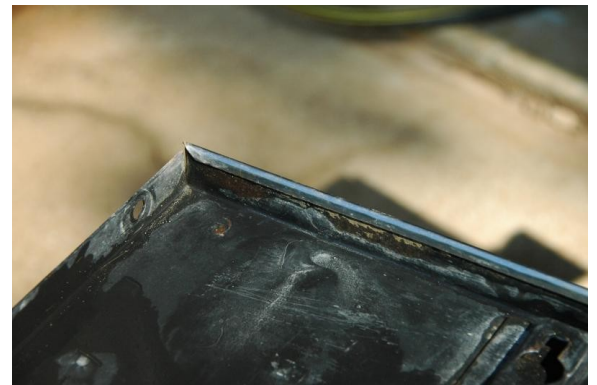
The running boards on the '29 have a shiny metal trim around the edge of the board. The original was polished zinc, but replacement parts in shiny stainless are available (as are zinc). Piranio's to the rescue!

The trim is formed to fit over the edge of the board, on top of the rubber, and then folded under the bottom lip.

to reuse them. Well, after ripping one set to shreds trying, I found a way to unbend the lip, and I suppose if a person was VERY careful, they could be salvaged.

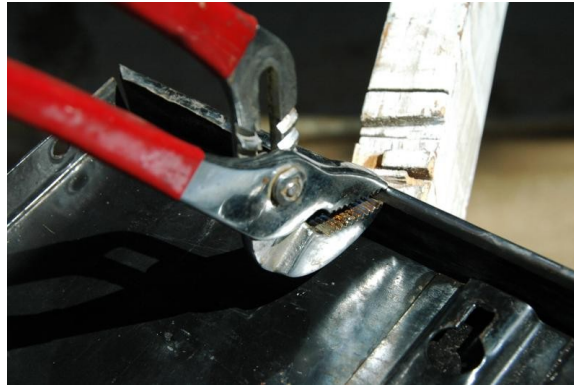
I found that using a large pair of channel lock pliers, you could just hook the edge of the trim, then rock the pliers back and take the bend out of the trim. Eventually you can take the trim off.

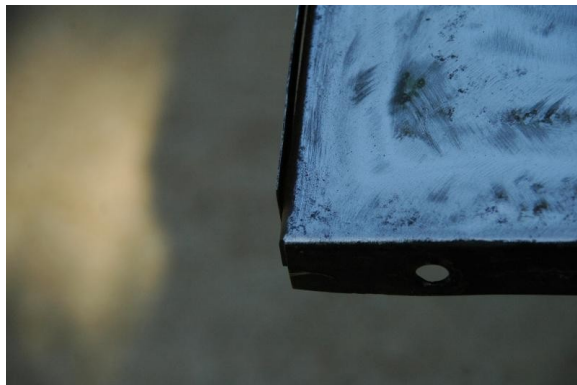
First off, getting all the old rubber off, the contact cement that it was glued on with and then to the bare metal underneath. Found some rust, but that was easily dispatched with the plastic mat grinder wheel that I have. That is until I started looking closely at the cracks where the metal pieces that form the running board are attached. Rust that I could not get to by hand, and no sand blasting available.

Looking closely at this picture, you can see the rust hiding back in the corners. I talked with Chuck Sportsman and Ken Parker and both suggested using

Ospho, phosphoric acid-based liquid that transforms the rust from iron oxide into iron phosphate, and then covering it with primer and paint. Off to Hilliards to buy some, and treated the rust to a lunch of it!

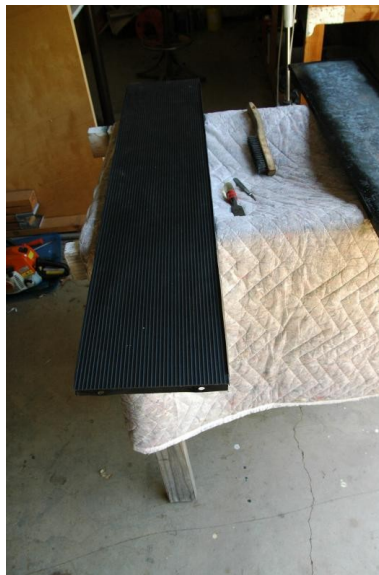
Resulting in this! Looking good!

Next step was to lay down the rubber mat. It comes with a very sticky back surface so all you need to do is peel off the protective paper and lay it in place. It's slightly longer than necessary, so trimming with an x-acto knife did the trick.

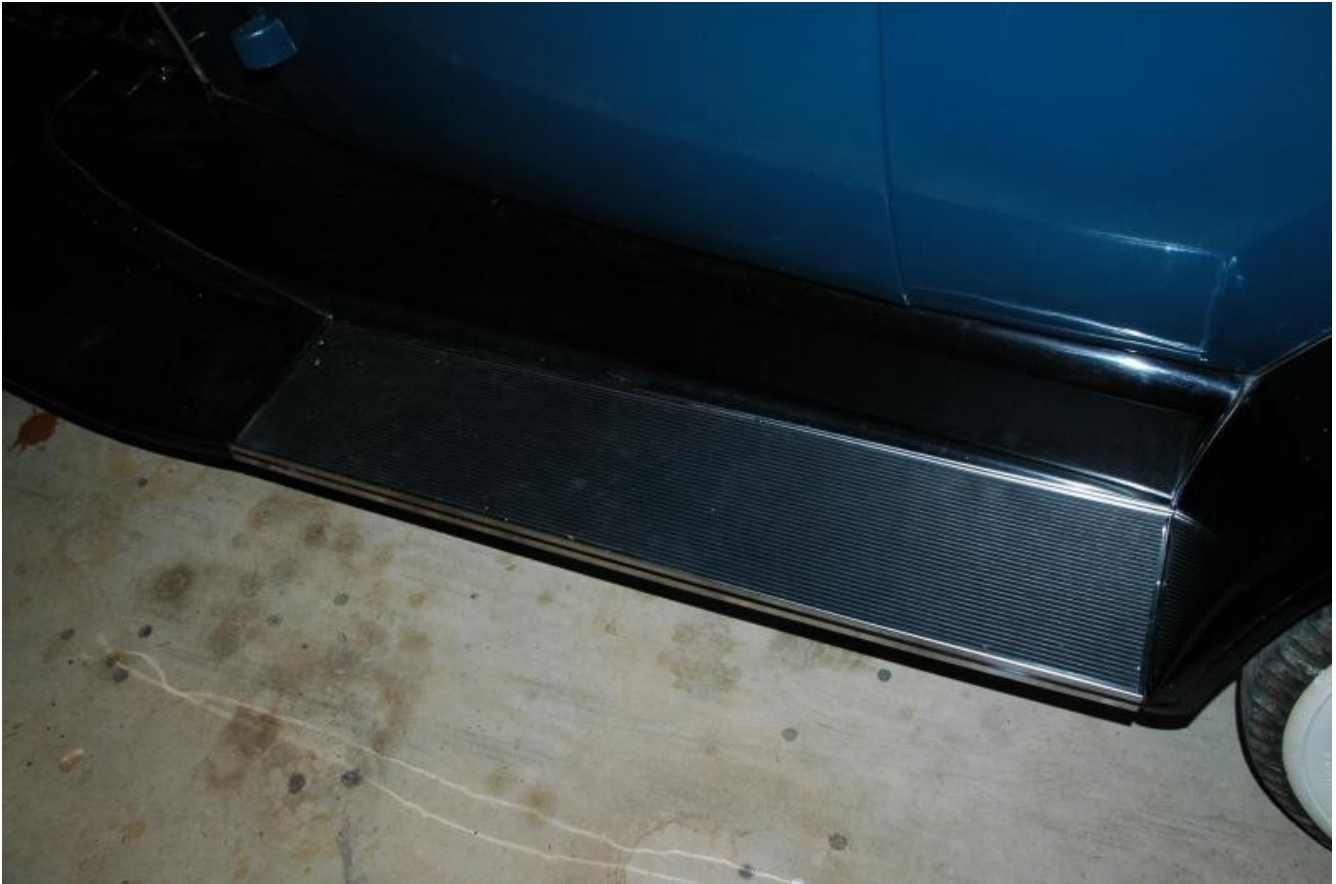
Once the trim is back in place, then the board needs to be re-mounted on the car. You need to check if there is any rust on the splash aprons where the boards meet, you need to make sure the running board braces are where they belong (I had one that was ... weird!) And this is what it looks like!
